87-20-03 R2 CESSNA: Amendment 39-5729, as revised by Amendment 39-5863, is further revised by Amendment 39-6669. Docket No. 86-CE-71-AD.

Airworthiness Directive 87-20-03 R2 revises AD 87-20-03 R1 (Amendment 39-5863) which revised AD 87-20-03 (Amendment 39-5729).

This amendment (39-6669, AD 87-20-03 R2) becomes effective on September 24, 1990.

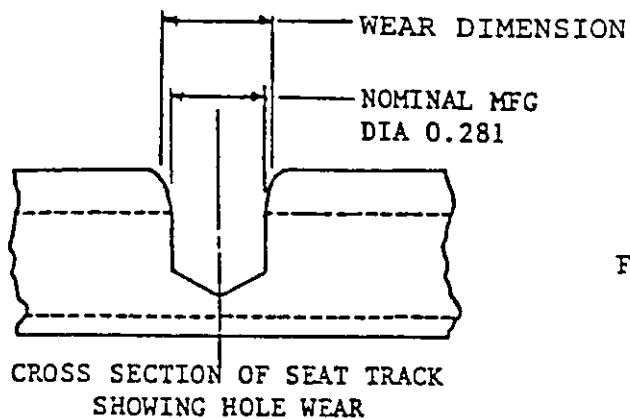
FIGURE 1

(1) Measure each hole in the seat track(s) for excessive wear. When checking these holes for wear, an allowance of 0.020 inches below the edge of the normal surface is permitted for the required measurement.

(i) If the wear dimension across any hole exceeds 0.36 inches but does not exceed 0.42 inches (see Figure 1), continue to measure each hole every 100 hours TIS for excessive wear.

(ii) If the wear dimension across any hole exceeds 0.42 inches, prior to further flight, replace the seat track.

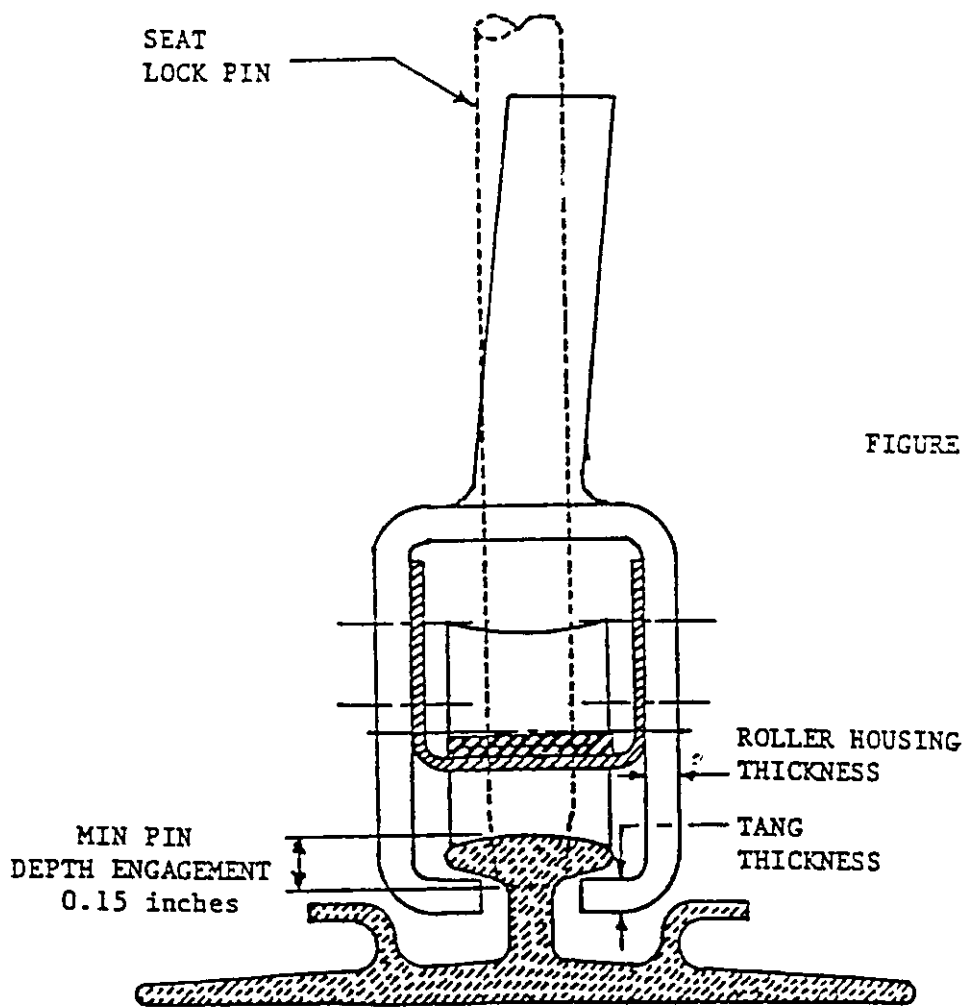
FIGURE 2

(3) Lift up on the forward edge of each seat to eliminate all vertical play. In this position, measure the depth of engagement of each seat pin. If the engagement of any pin is less than 0.15 inches (see Figure 2), prior to further flight, replace or repair necessary components to achieve a seat pin engagement of 0.15 inches or greater. If the track is worn, this dimension is measured from the worn surface, not the manufactured surface.

(5) Measure the wall thicknesses of the roller housing and the tang (see Figure 2). If the tang thickness has worn to less than 1/2 the housing thickness, prior to further flight, replace the roller housing.
