# multi-engine SERVICE LETTER

ME78-2  
(Supplement #1)

SUBJECT: FRONT AND REAR WING SPAR INSPECTION

## FRONT & REAR SPAR CAP INSPECTION INSTRUCTIONS

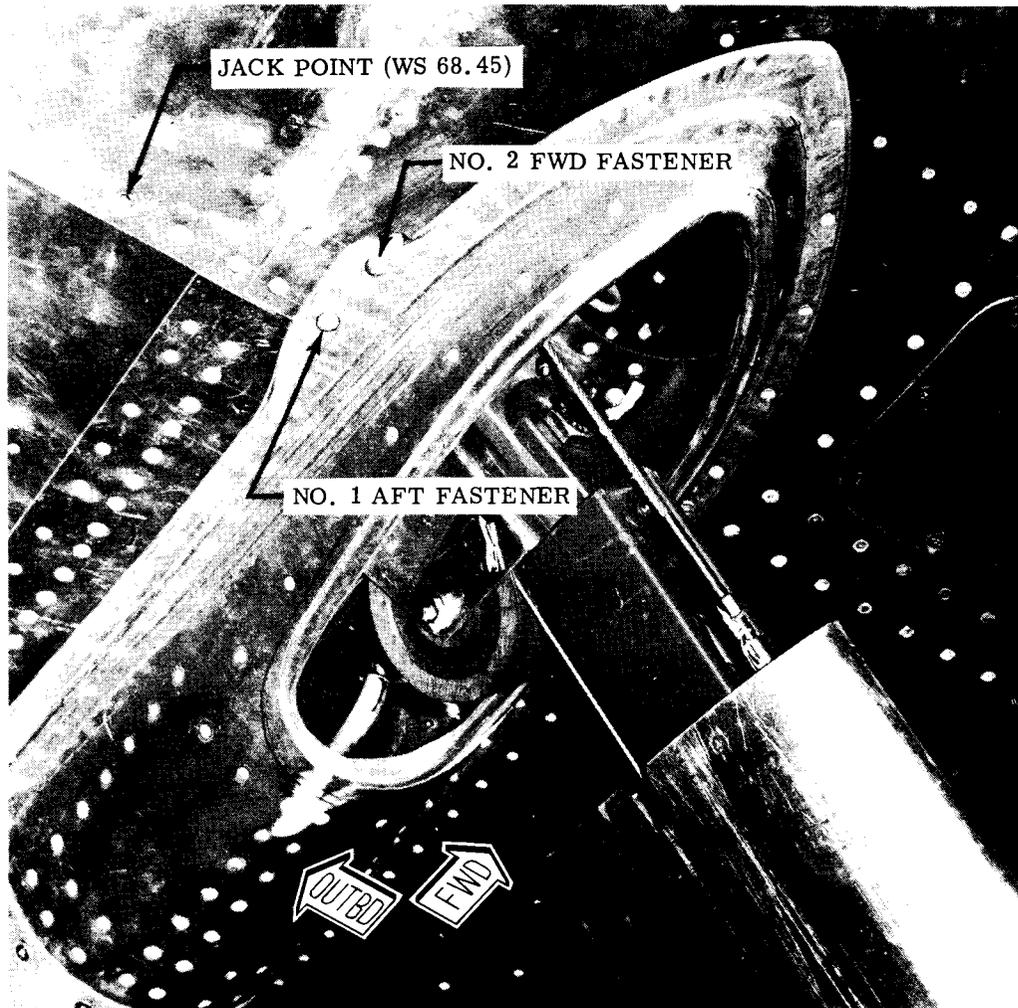
Figure 1.

The area to be inspected is immediately outboard of the wing-strut attachment. Figure 1 shows this area, two fasteners (NAS 221 screws located at Wing Station 64.41) and the Jack Point screw that must be removed for the inspection. The NAS 221 screws secure the outboard edge of the boom, the lower wing skins, a doubler plate, the horizontal flanges of the lower spar cap and angles on top of the lower spar cap. A cross section of Wing Station 64.41 with the screws removed is shown in Figure 2. A cross section of the Jack Point location (Wing Station 68.45) is shown in Figure 5.

WING STRUT ATTACHMENT AREA

WITH STRUT CUFF REMOVED

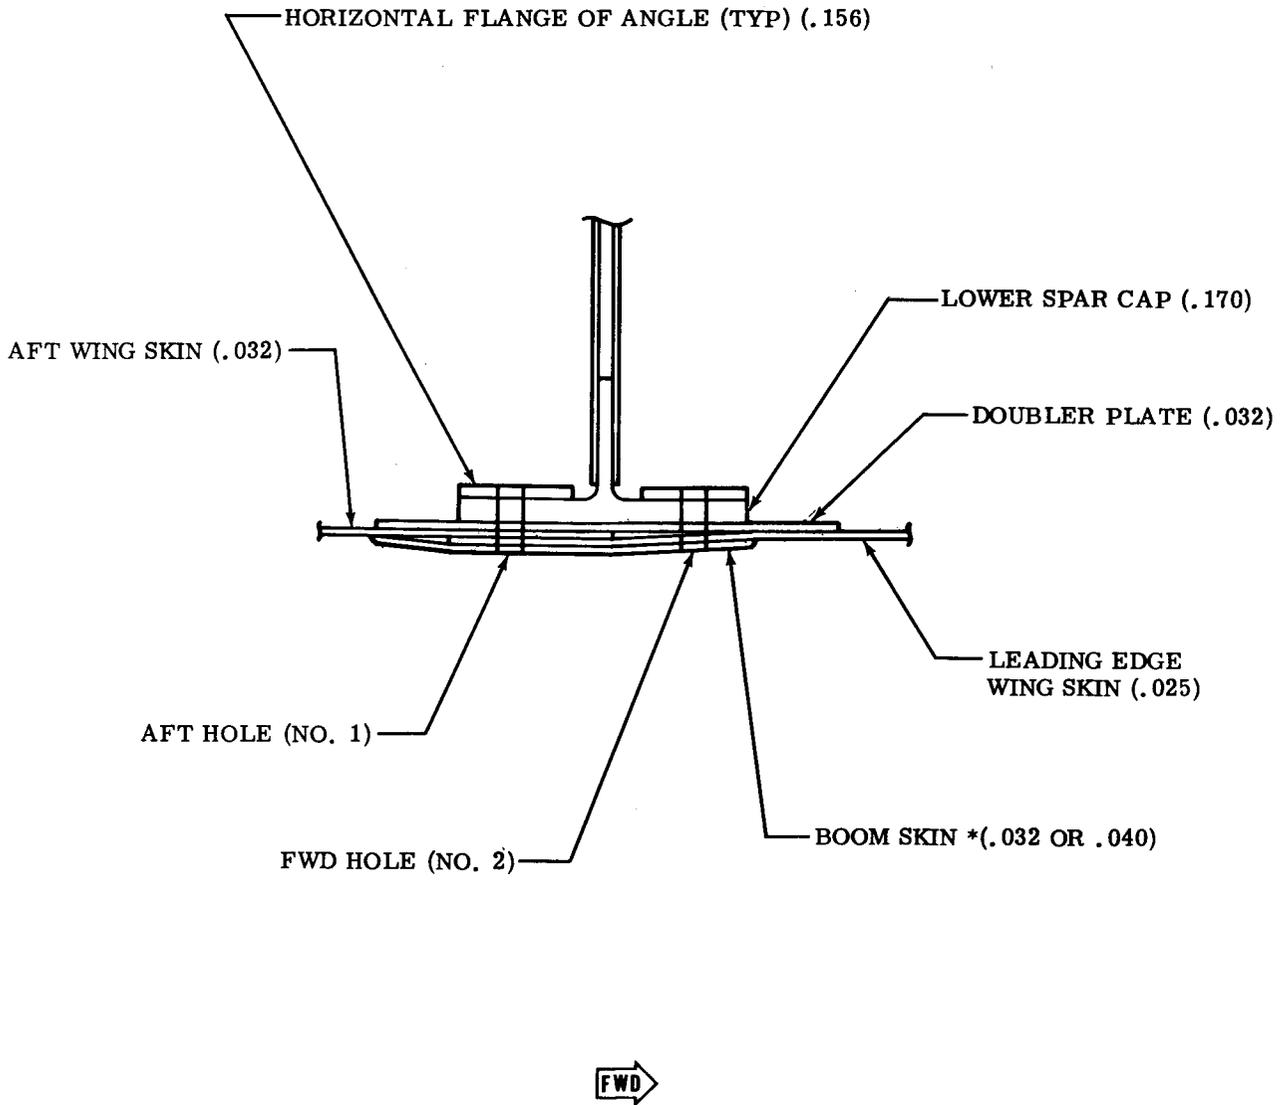
Figure 2.

LOWER SPAR CAP AT FASTENERS

WING STATION 64.41

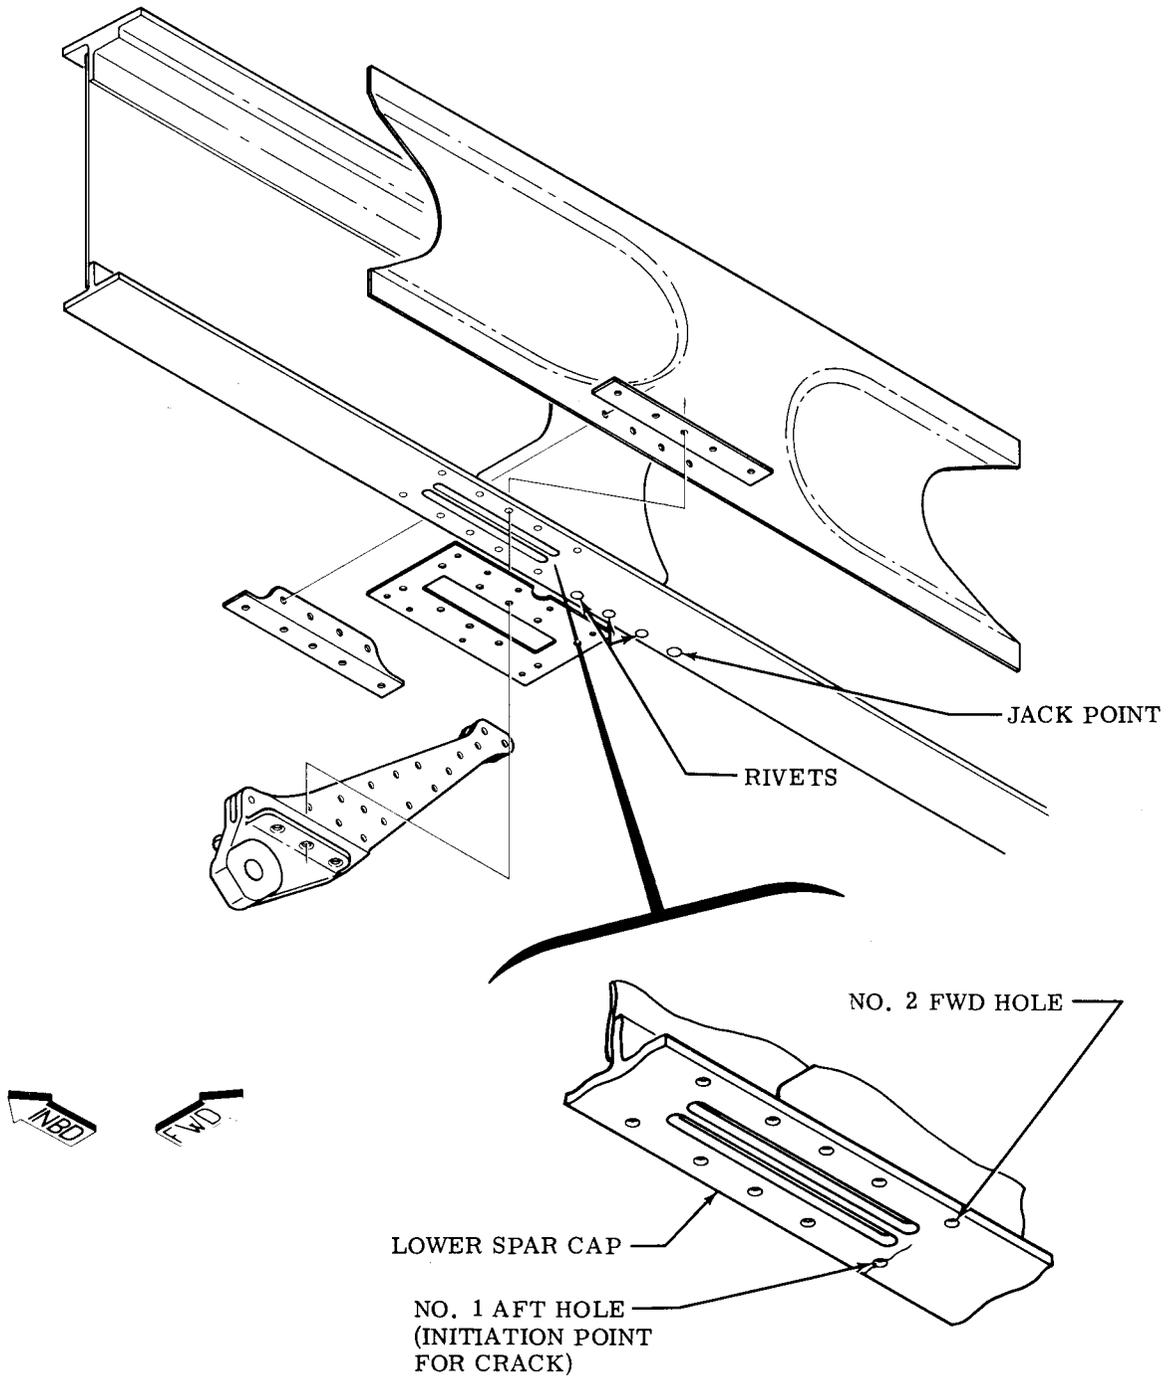
The lower spar cap is a T-section and the material is 2014-T6 or 2014-T6511, depending on the year the aircraft was manufactured. An exploded view of the spar assembly (less boom and wing skins) shows the relationship of the lower cap to the other parts at the strut attachment in Figure 3. Also shown in this figure is the initiation point for the crack mentioned in Service Letter ME72-26.

FRONT WING SPAR-BOOM & STRUT ATTACHMENT AREA

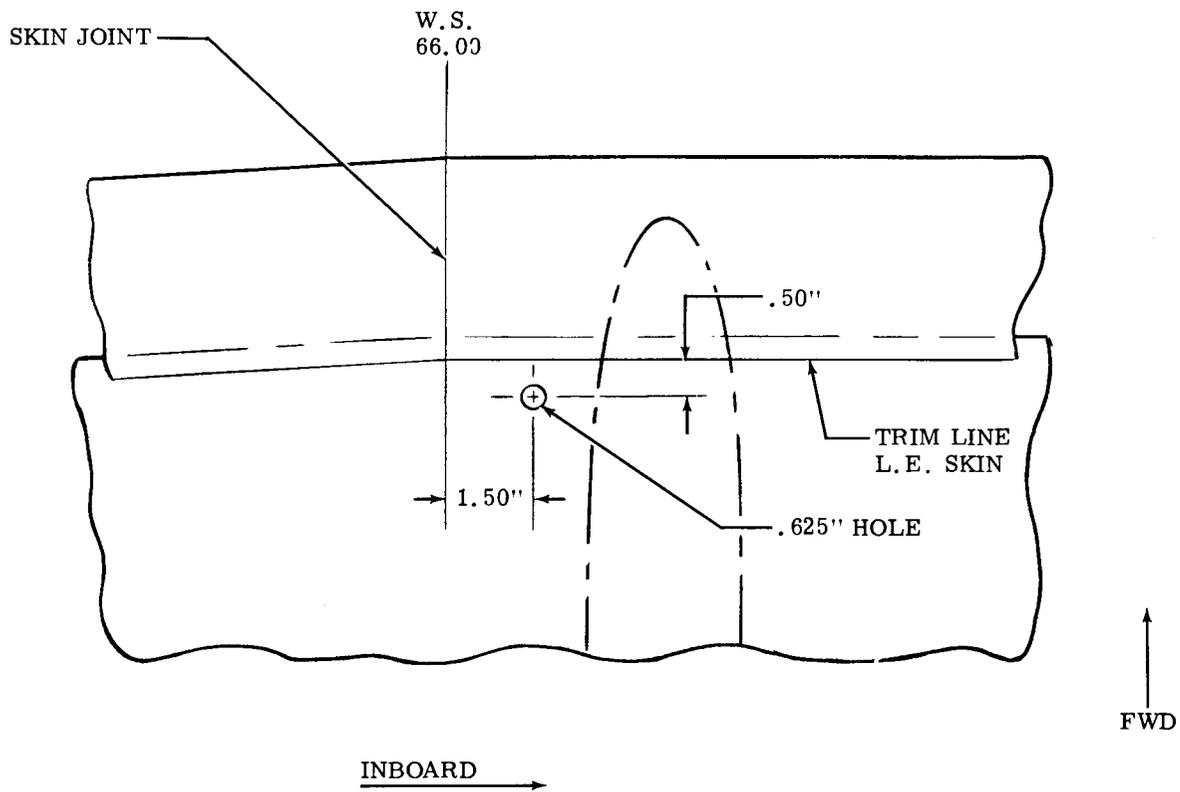
ADDITION OF ACCESS HOLE FOR NO. 1 AFT FASTENER

WING STATION 64.41

1. Remove wing strut fairings.
2. Remove upper wing strut cuffs.
3. Drill a .625 inch hole in the upper wing skins outboard of the booms as shown in Figure 4. Before drilling, make certain that the hole location is centered as far away from stringers, rib flanges and spar flanges as possible. The hole must not be drilled through any of these. After drilling, the edge of the hole must be polished to remove any defects from which cracks could initiate.

- After the inspection has been completed, a .625 inch plug button must be installed in the hole and sealer added around the hole to prevent moisture from entering the wing through this hole.
- The area around the hole should be carefully inspected (visually) at each 100 hour and/or annual inspection period to assure that if any skin cracking occurs, it will be caught at an early stage.

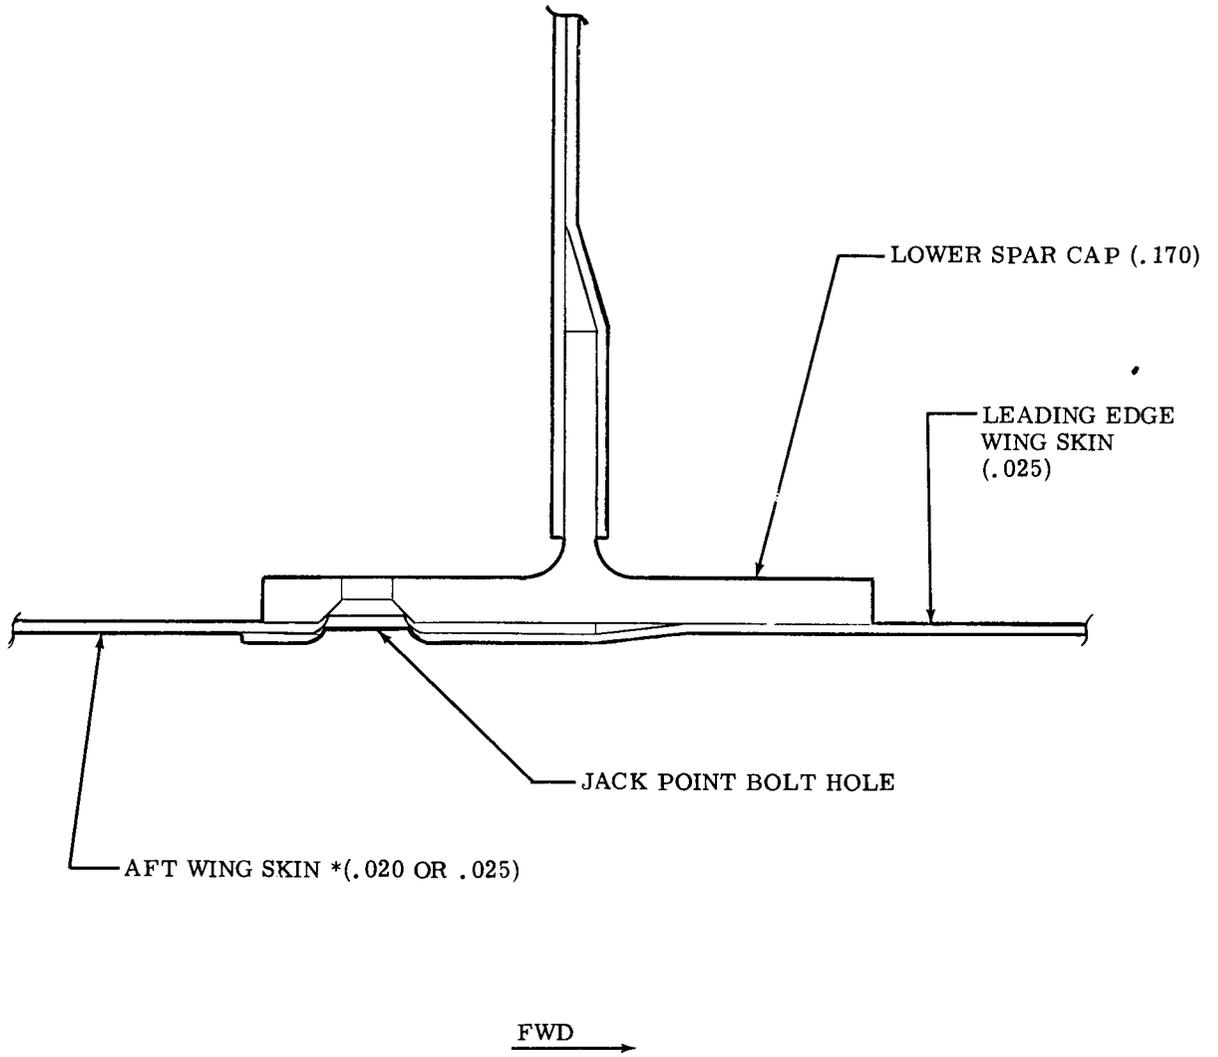
Figure 5.

LOWER SPAR CAP AT JACK POINT

WING STATION 68.45

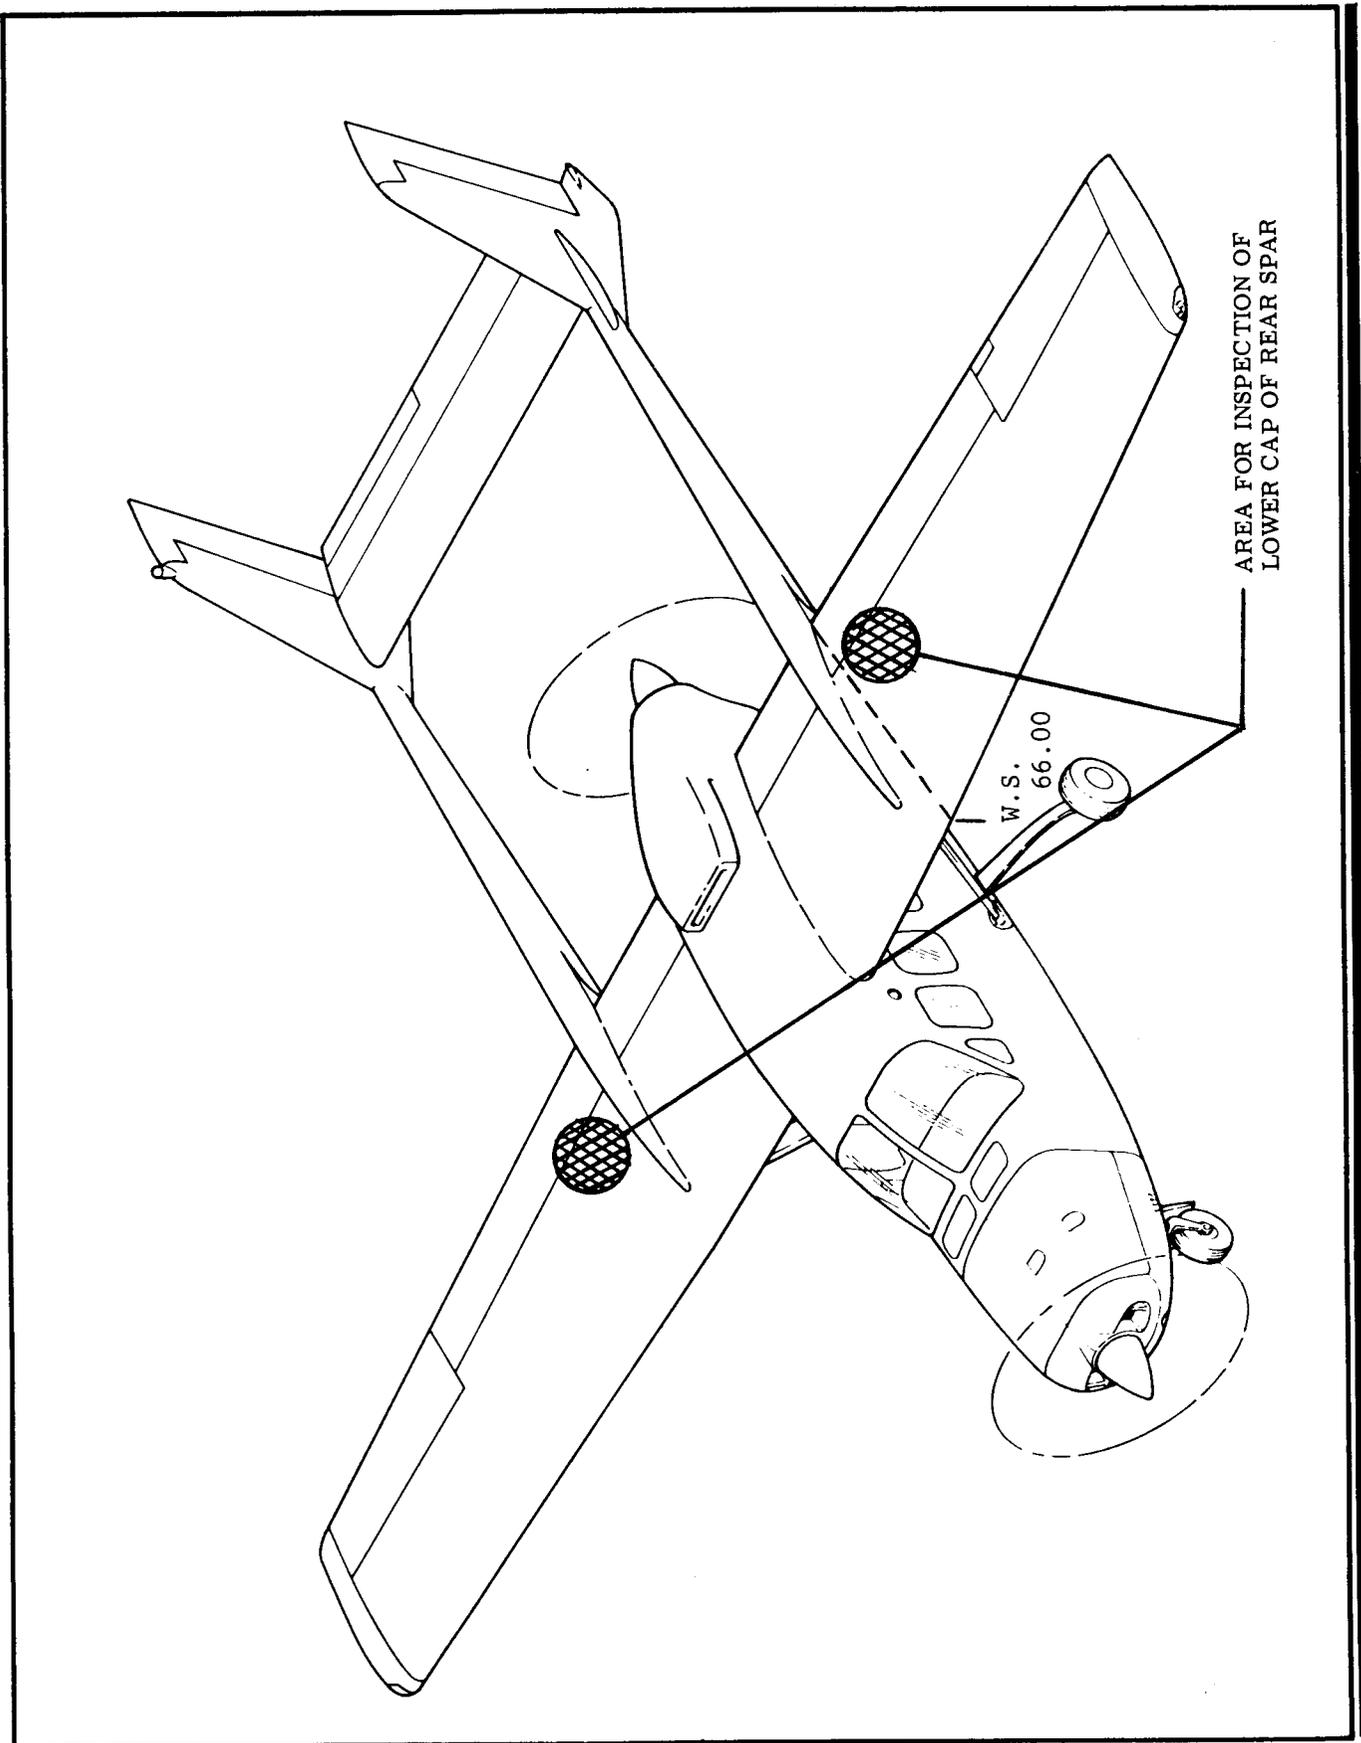
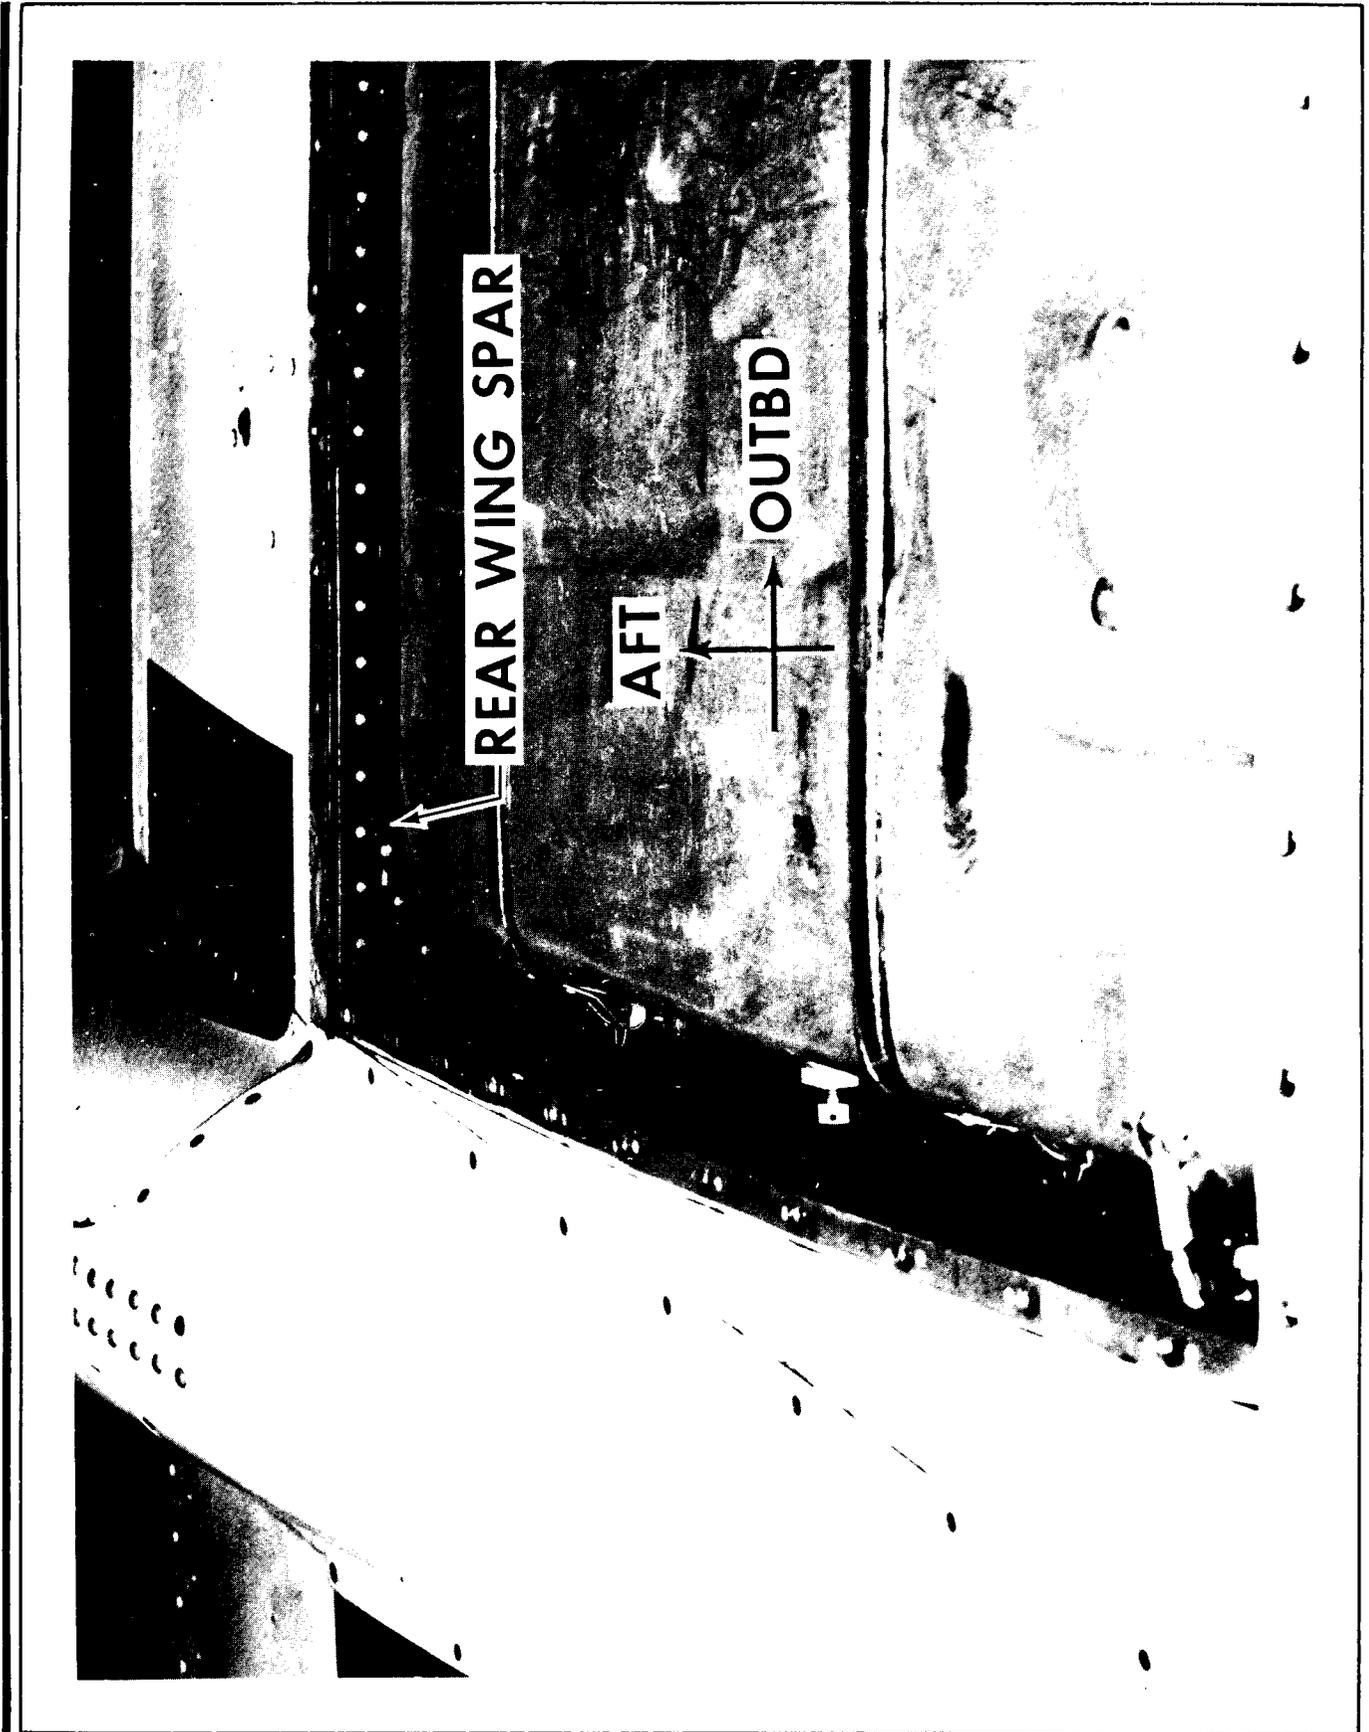
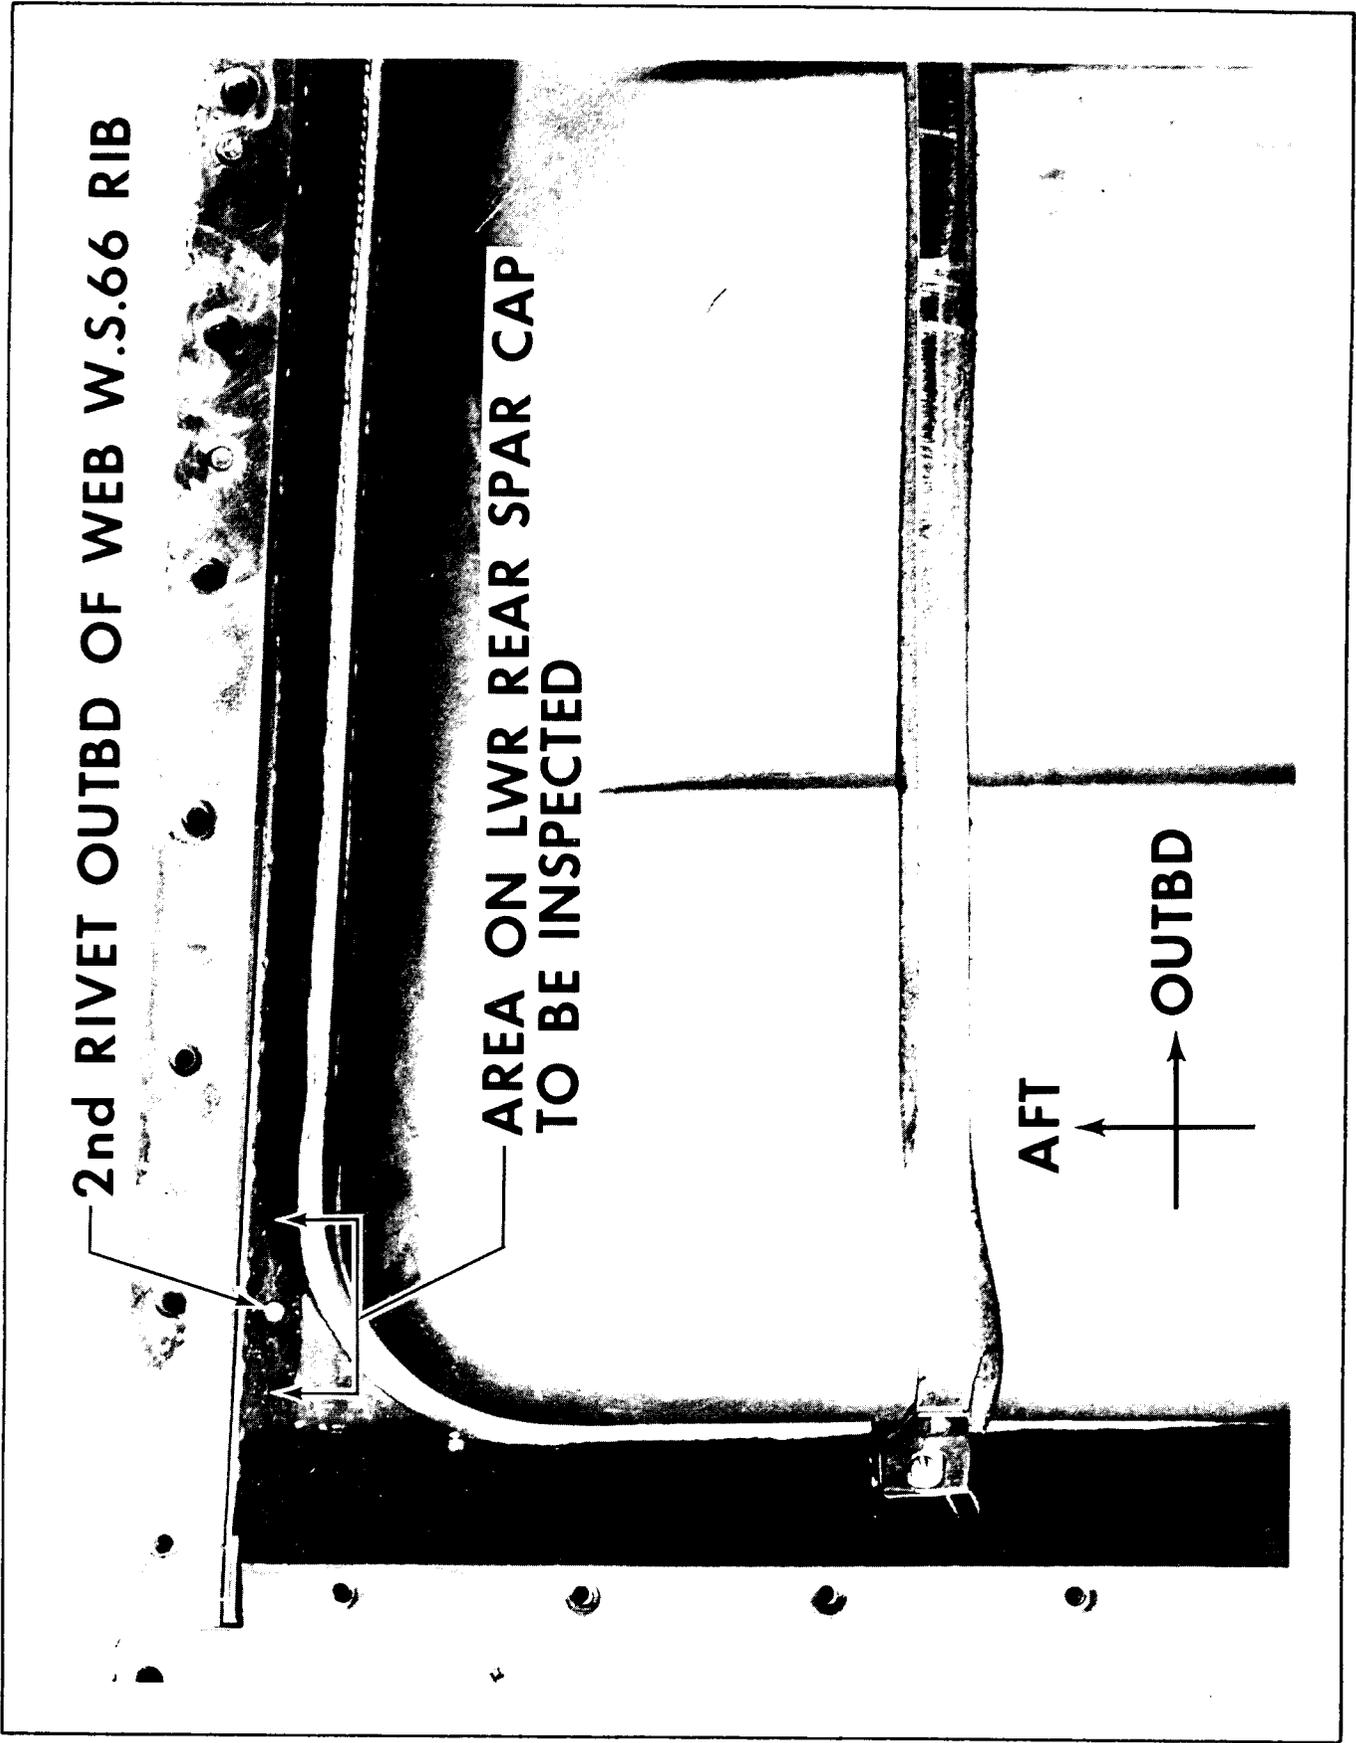
1. Dye penetrant inspect lower spar cap over an area ranging from 2 to 3 inches outboard of the Wing Station 66.00 rib. (Refer to figures 6, 7 and 8)

Figure 6. Rear Spar Lower Cap Inspection.

Figure 7. Left Rear Wing Spar. (fuel tank cover removed)

Figure 8. Inspection Area.

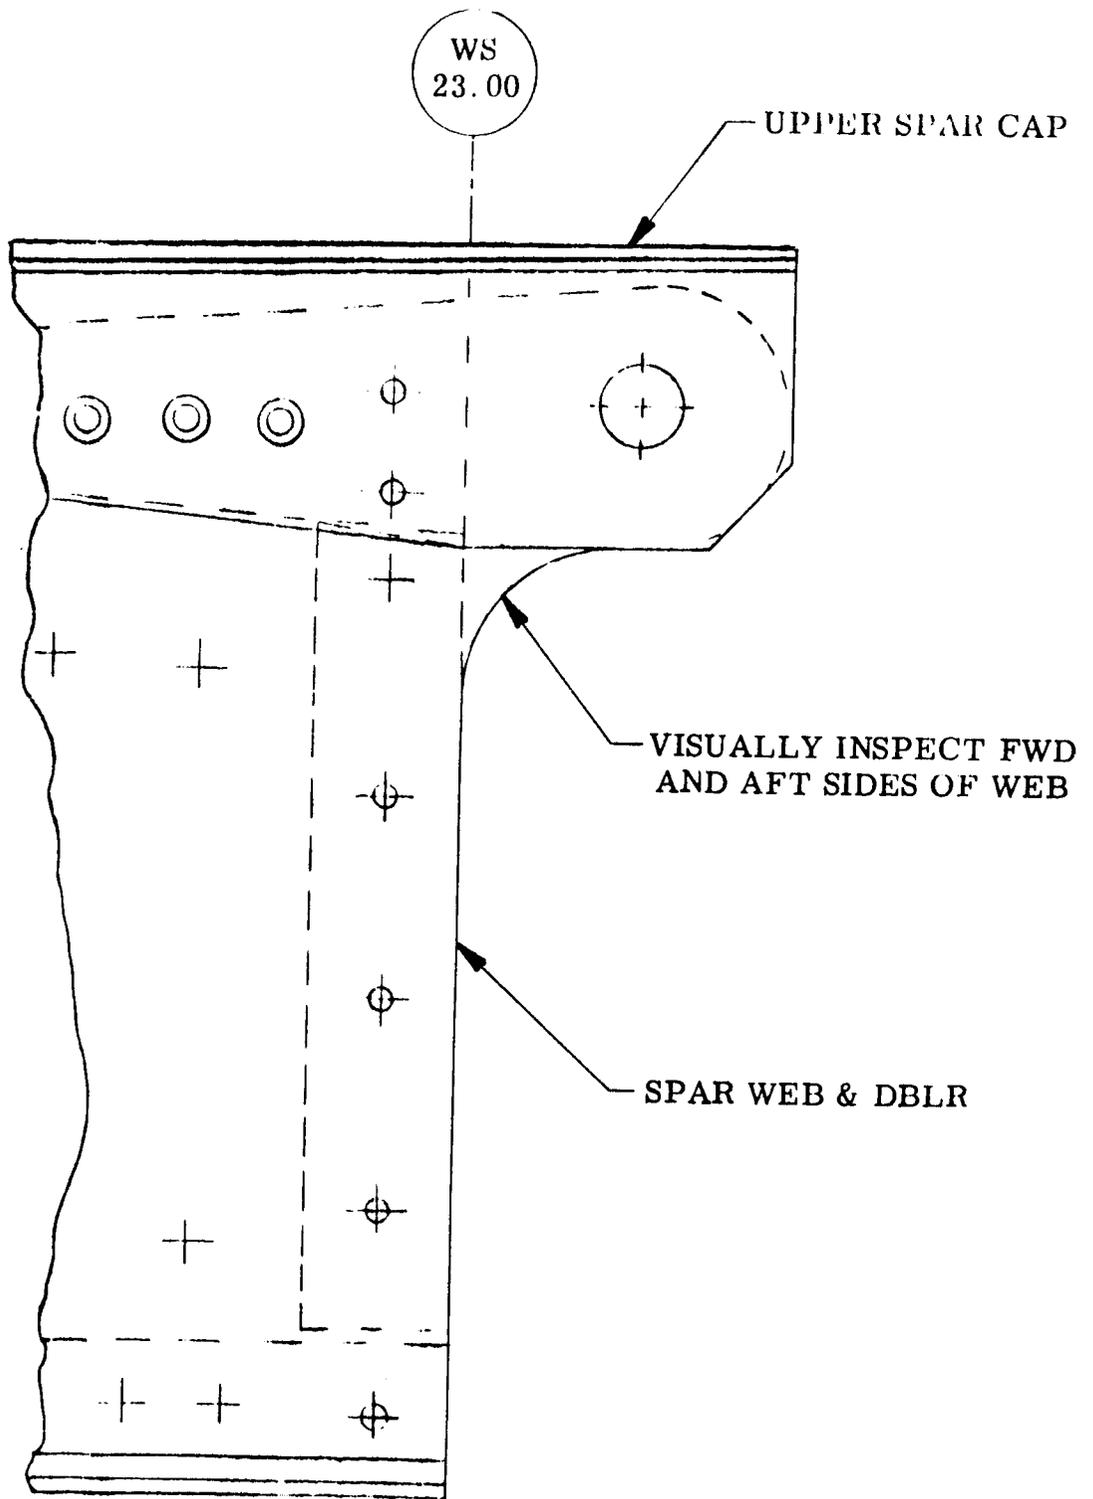
FIGURE 9

- 3) Figure 9 of the inspection instructions has been revised to include more detail of the front spar inboard end (attached).

1. Visually inspect the radii of both the spar web and the web doubler in the shaded area as shown in Figure 9.

In the event that cracks are found in the spar web and web doubler, these parts must be replaced.
