THE C-336 SKYMASTER STORY

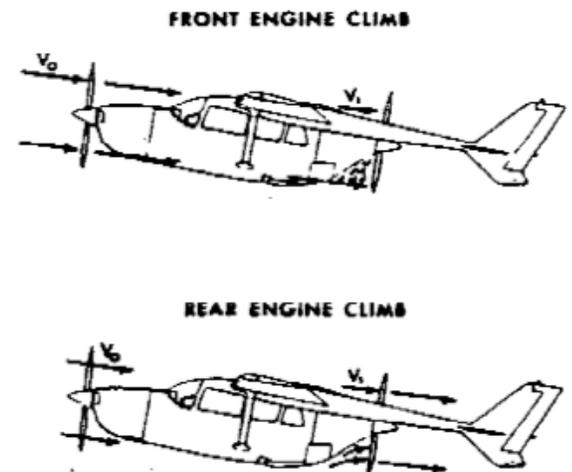
Fig. 1 — Propeller inflow and slipstream effects in single-engine climb

attachment to the bluff afterbody of the rear cowl” as illustrated in figure 1. Later he proved to be right and collected the doubters’ money! Test results showed the rear engine to have a 24% rate-of-climb advantage over the front engine only operation.

As we prepare for the first flight, everyone was taking bets on which engine would give the best engine-out climb. Dave Bierman, chief engineer at Hartzell Propeller Company (and former longtime aerodynamics research engineer at NACA) put his money on the rear engine. He explained "The rear engine propeller has no blockage behind it, its diameter is two inches greater, its inflow velocity is favorably reduced, and it promotes better airflow

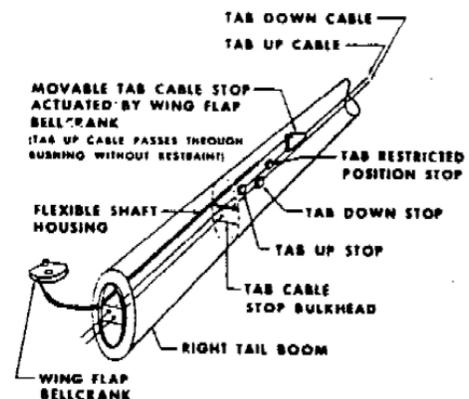
We also looked for an interconnect system that would automatically change the trim tab setting as the flaps were extended and retracted electrically. Bill Seidel, assistant project engineer, designed a clever device that “semi-automatically” reduced very heavy out-of-trim elevator forces in balked landing climb-outs when the flaps were retracted as illustrated in Figure 2. The progression of elevator stick force changed

Fig. 2 - Elevator trim/wing flap interconnect system

As power is applied, the nose-up trim must be counteracted by a 40-pound push force. Then as flaps are retracted (removing a powerful nose-down pitching moment) an additional push force up to 80-pound is required to maintain the original trim speed. This test increment of push force was eliminated very neatly by Bill's invention. The elevator trim tab cables are routed down the right tail boom. A flexible shaft connects to one arm of the wing flap bellcrank and engages a swaged ball on the tab cable during part of its travel.

With flaps retracted, the pilot can trim the elevator tab to no more than 10 degrees with flaps extended, the flexible shaft moves aft, permitting additional manual adjustment of the tab to 26 degrees. Conversely, when the flaps are retracted electrically from 30 to 15 degrees, the flexible shaft automatically drags the tab cable from the original position to 10 degrees. This relieves the out of trim force to 20-pounds as shown in the aforementioned graph. In addition, it relieves the pilot from manually making large trim wheel rotations during this period of high activity by the pilot.

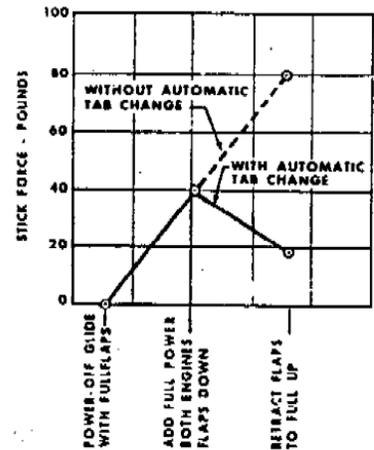
from a landing configuration glide to a balked-landing-climb and, finally, to a flaps-retracted climb is illustrated graphically in Figure 3.

Fig. 3 - Longitudinal trim changes in balked landing go-around

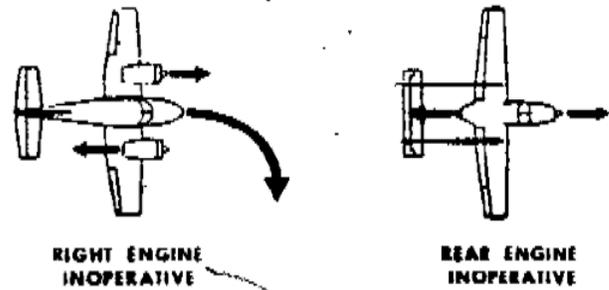
Fig. 4 - Effect of engine failure on directional control

vectors with an engine out are shown in Figure 4 with comparative take off profiles and graphical comparisons of total take-off distances in Figures 5 through 8. The flight path shown by the solid line in Figure 5 indicates the normal twin-engine climb-out path, and the dotted lines represent (schematically) two possible flight paths with an engine failure. In the speed range marked “area of decision” the pilot chores are compared in the following paragraphs:

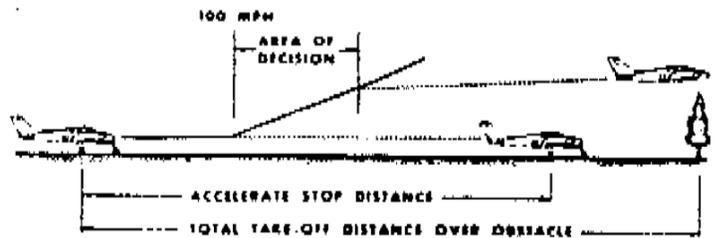
Fig. 5 - Single engine take-off - conventional twin

1. The conventional twin will yaw sharply in the direction of the failed engine, and if the speed is below V_{mc} it will also roll in that direction.
2. Counteract yaw and roll with full opposite rudder and partial opposite aileron while maintaining at least V_{mc} speed and a constant heading.

3. Decide whether to terminate or continue the take off. Assuming that the take off is to be continued, retract the landing gear.
4. Identify the failed engine, remembering that “idle foot identifies idle engine”.
5. Feather the windmilling propeller.
6. Trim the rudder tab to counteract asymmetric thrust.
7. Accelerate to V_y climb speed (or V_x speed with obstructions ahead).
8. Climb over any obstructions at the end of the field.
9. Maneuver around obstructions while circling the field for an emergency landing.

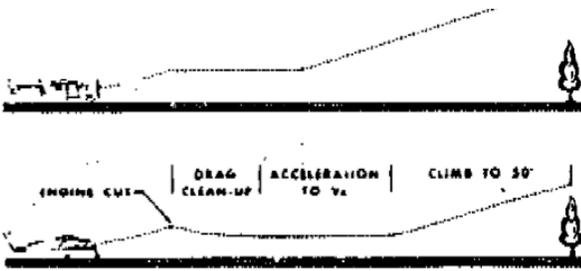
Fig. 6 - Take-off profile with engine cut at $1.2 V_s$

In comparing the last two take-off profiles, one can see that the CLT twin’s engine-out take-off distance advantage is amplified as the airspeed at engine cut is reduced from 1.2 Vs to 1.1 Vs in this case the conventional twin has no alternative but to discontinue the take-off because the engine cut occurs at an airspeed lower than minimum control speed (Vmc). In contrast, the CLT airplane is able to continue with the take-off since its Vx speed is very close to the 1.1 Vs speed. These comparisons are illustrated convincingly in Figure 8, showing numerical distances as a function of engine-out speed.

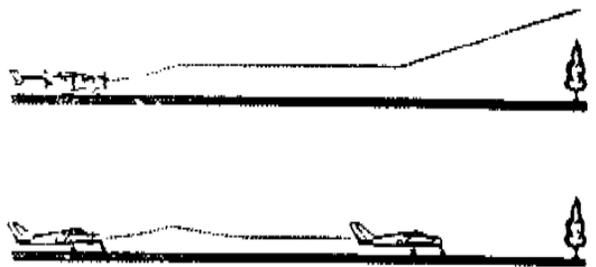
Fig. 7 - Take-off profile with engine cut at $1.1 V_s$

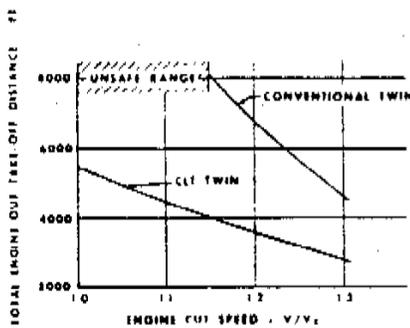
Fig. 8 - Effect of engine cut speed on total take-off distance over 50 ft obstacle

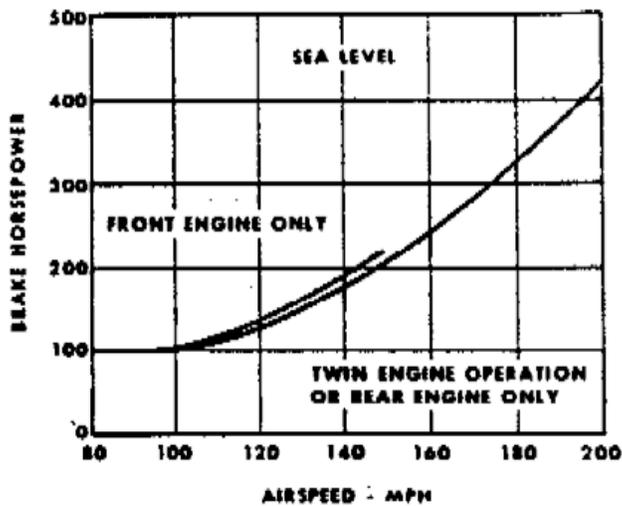
Fig. 10 - Effect of front or rear engine operation on speed-power

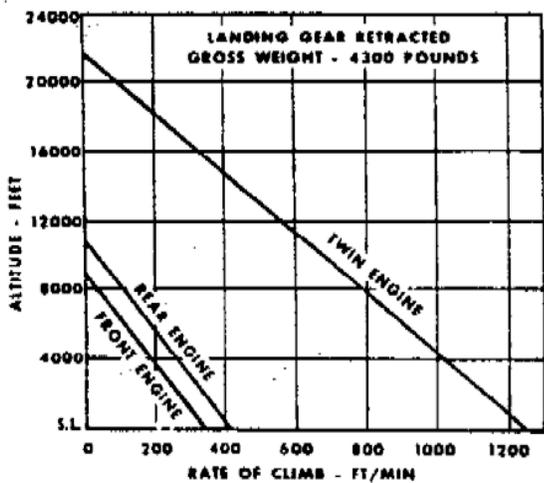
Fig. 11 - Rate of climb versus altitude

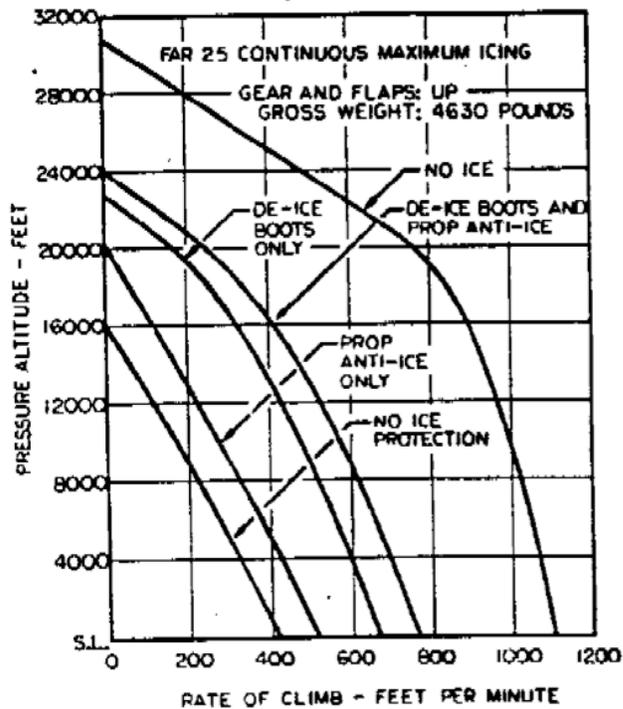
Fig. 12 - Icing climb performance decrements for Super Skyman
